Little Lick Creek Local Watershed Plan

Developed by the North Carolina Ecosystem Enhancement Program

Produced by the Upper Neuse River Basin Association, Center for Watershed Protection, and North Carolina Division of Water Quality

December, 2006

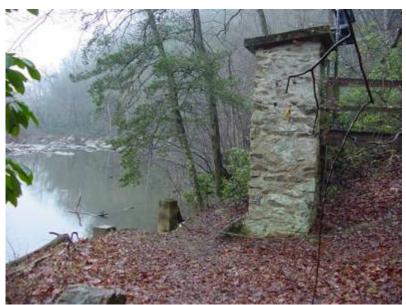
Figure 18. Stream flow gages are crucial for monitoring water quality and flow (USGS Gage Site on the Flat River).

- Establish annual stream walks to gage the progression of in-stream erosion
- Establish a long term flow gage in Little Lick Creek
- An effective program must involve citizens
- Monitor flow and nutrient loading to Falls Lake
